Photographic Log

Site Name:
Collierville High School

Tracking No.:
TN0081787

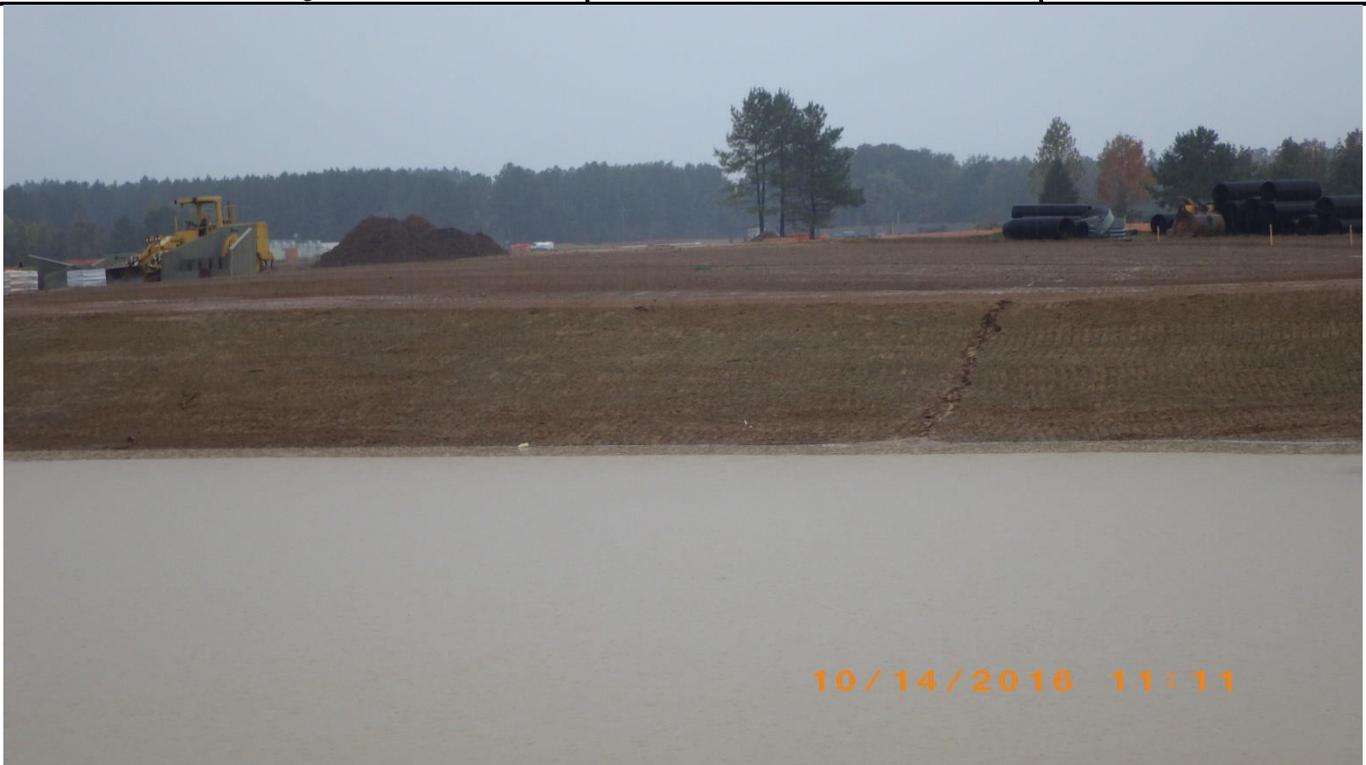
Photo 46. View of a rill that had formed on the bank of the NE sediment basin since the October 10, 2016, inspection. EPSC measures have not slowed runoff so that rill and gully formation is prevented as required by the TN Individual Construction Permit TN0081787.

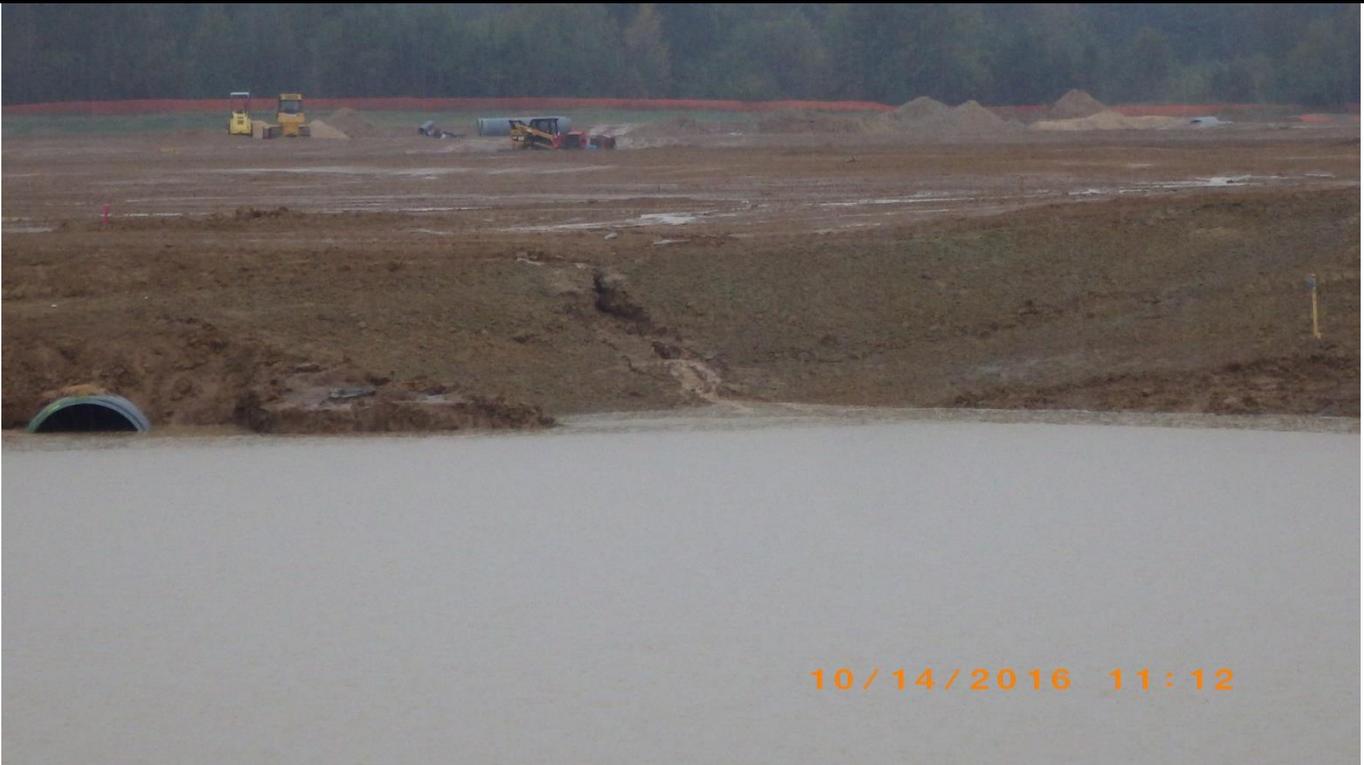
Photo 47. View of the large rill that had formed on the bank of the NE sediment basin near the stormdrain outlet since the October 10, 2016, inspection. EPSC measures have not slowed runoff so that rill and gully formation is prevented as required by the TN Individual Construction Permit TN0081787.

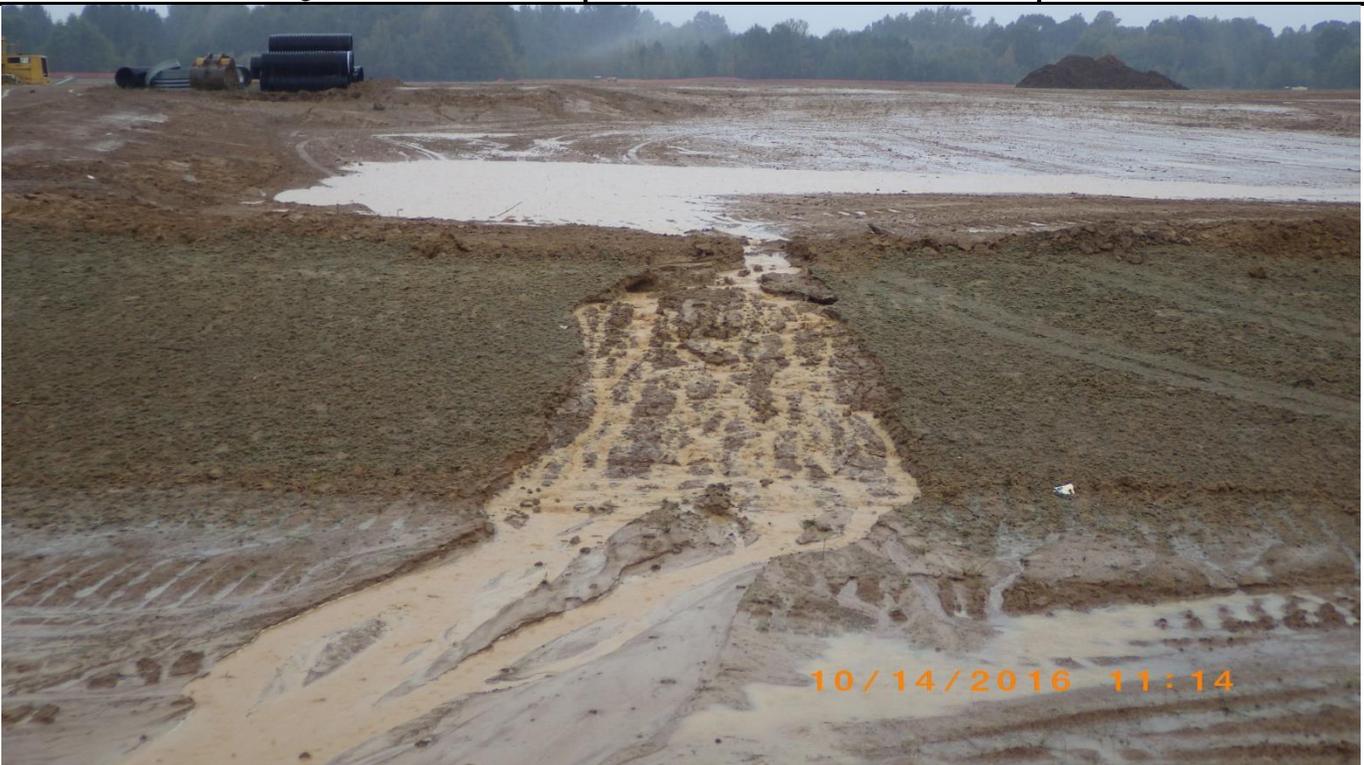
Photo 48. View of the large rill that had formed on the bank of the NE sediment basin since the October 10, 2016, inspection. EPSC measures have not slowed runoff so that rill and gully formation is prevented as required by the TN Individual Construction Permit TN0081787.

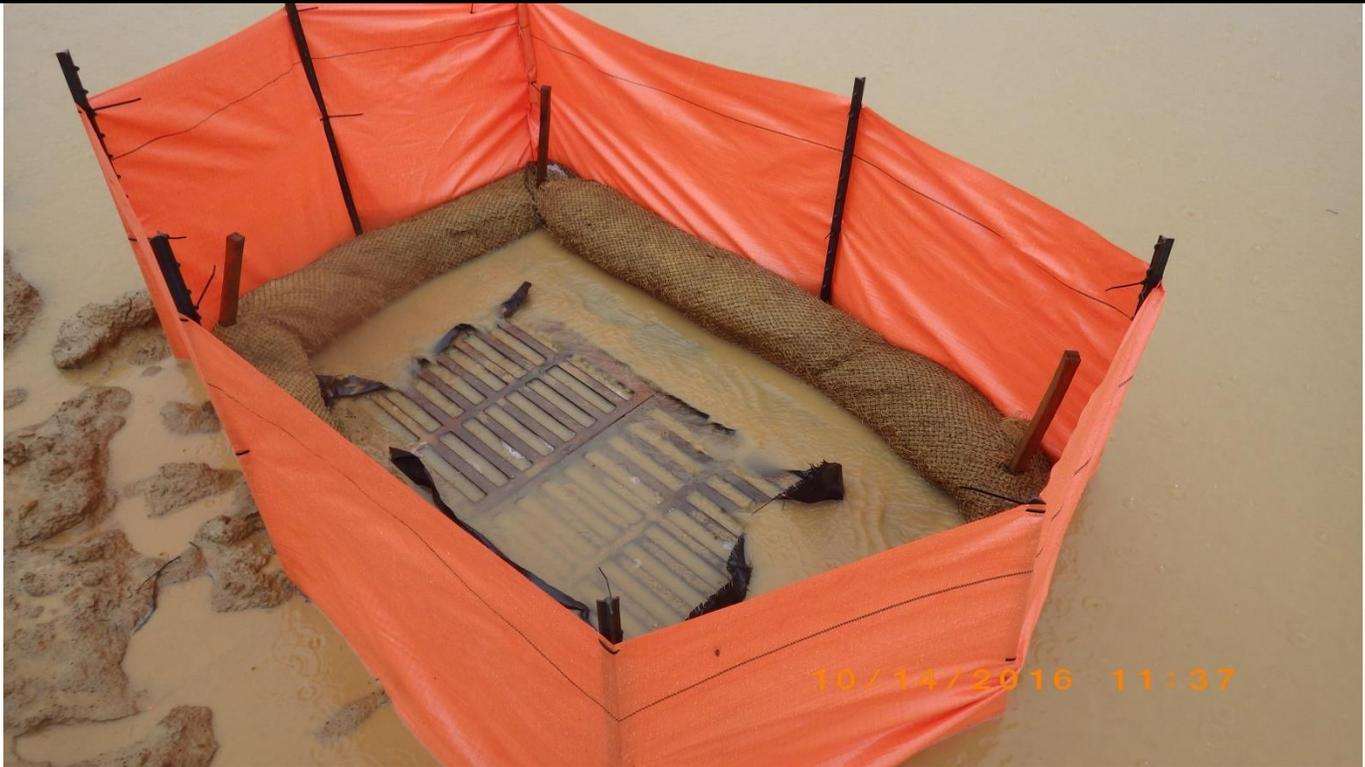
Photo 49. Sediment laden stormwater was observed flowing into the stormdrain system through a stormdrain inlet located near the partly sodded drainage channel that discharges into the NW sediment basin. This is the same stormdrain inlet that is shown in Photo 25.

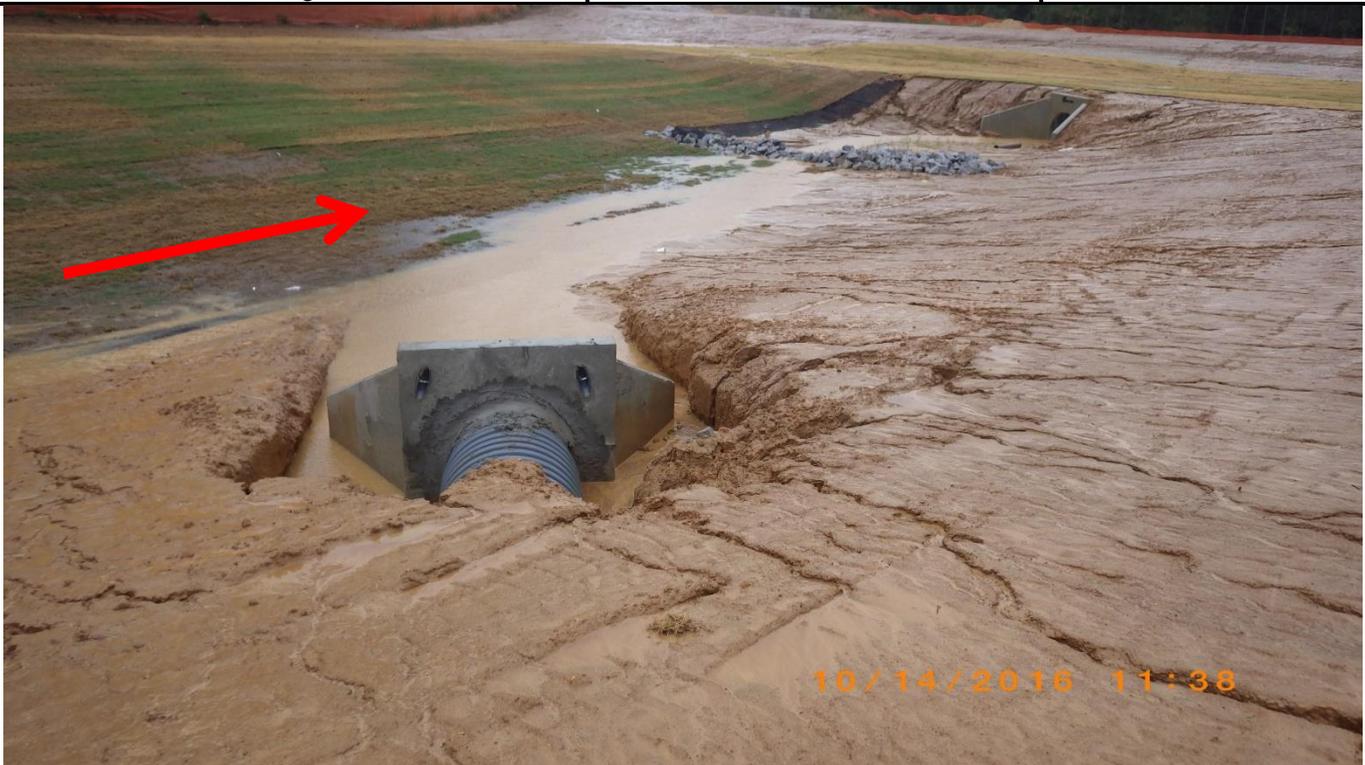
Photo 50. Stormwater that enters the stormdrain system through the inlet shown in Photo 49 is discharged into the partly sodded channel through an outlet structure that is surrounded by eroding soil and no sediment control measures were installed. EPSC measures have not slowed runoff so that rill and gully formation is prevented as required by the TN Individual Construction Permit TN0081787. The direction of flow is indicated with a red arrow.

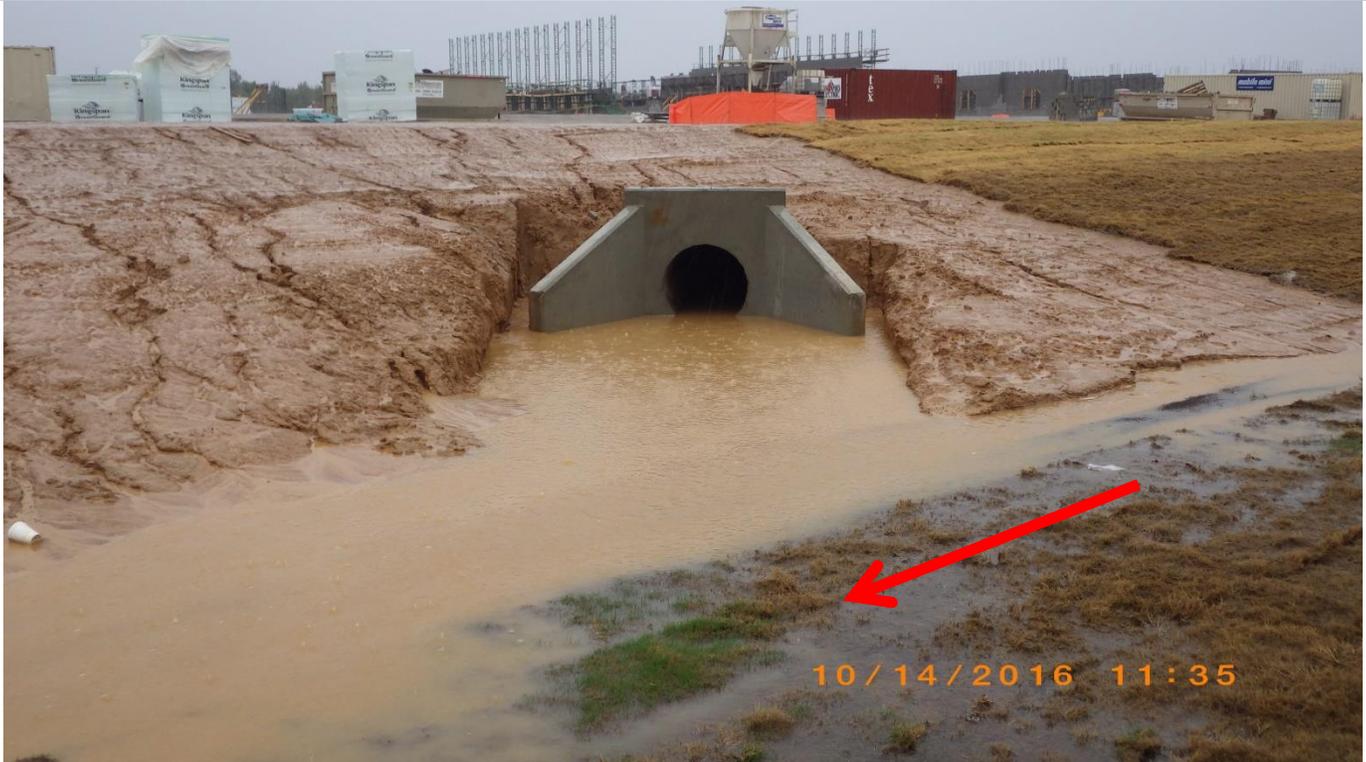
Photo 51. Another view of the stormdrain outlet shown in Photo 50. EPSC measures have not slowed runoff so that rill and gully formation is prevented as required by the TN Individual Construction Permit TN0081787. The direction of flow is indicated with a red arrow.

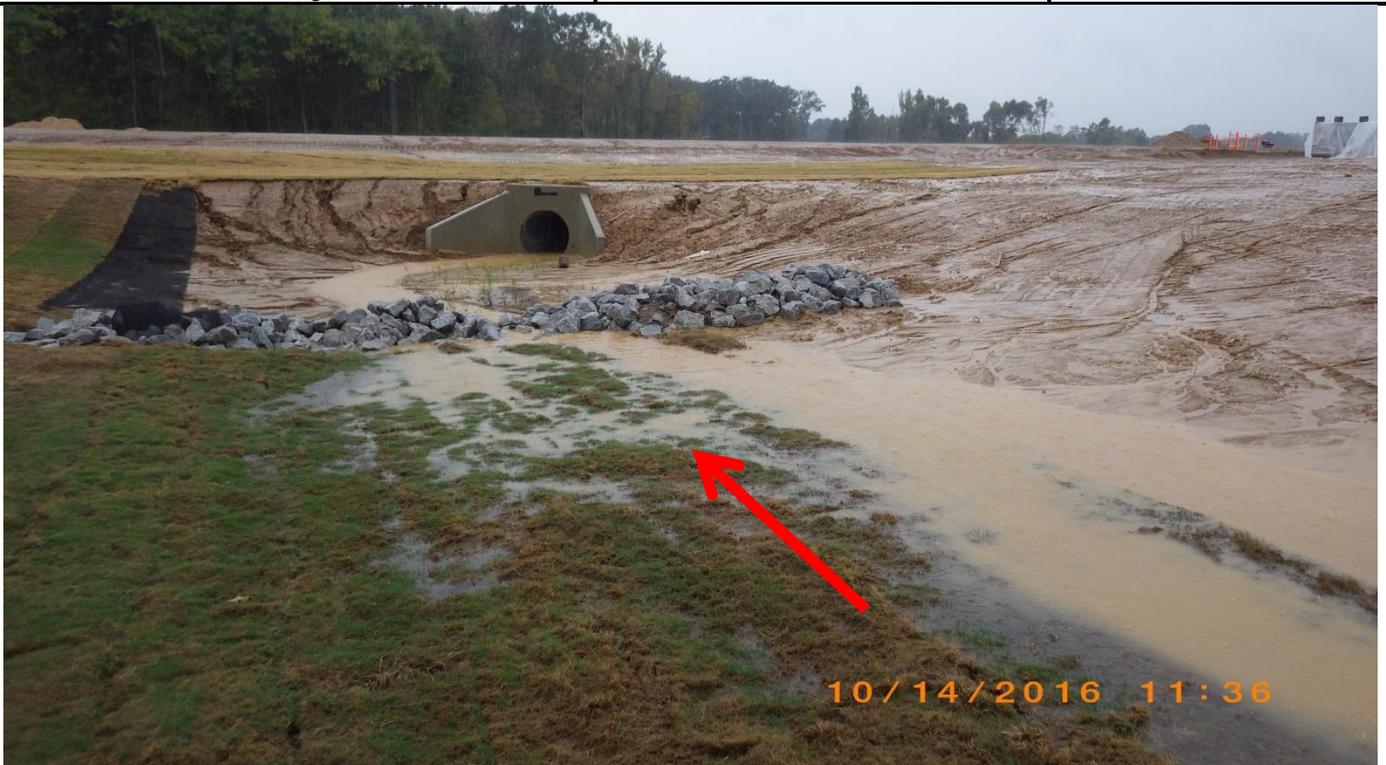
Photo 52. Once discharged into the partly sodded channel the sediment laden stormwater flowed through a check dam and into a culvert under an entrance road located north of the main construction entrance. The direction of flow is indicated with a red arrow.

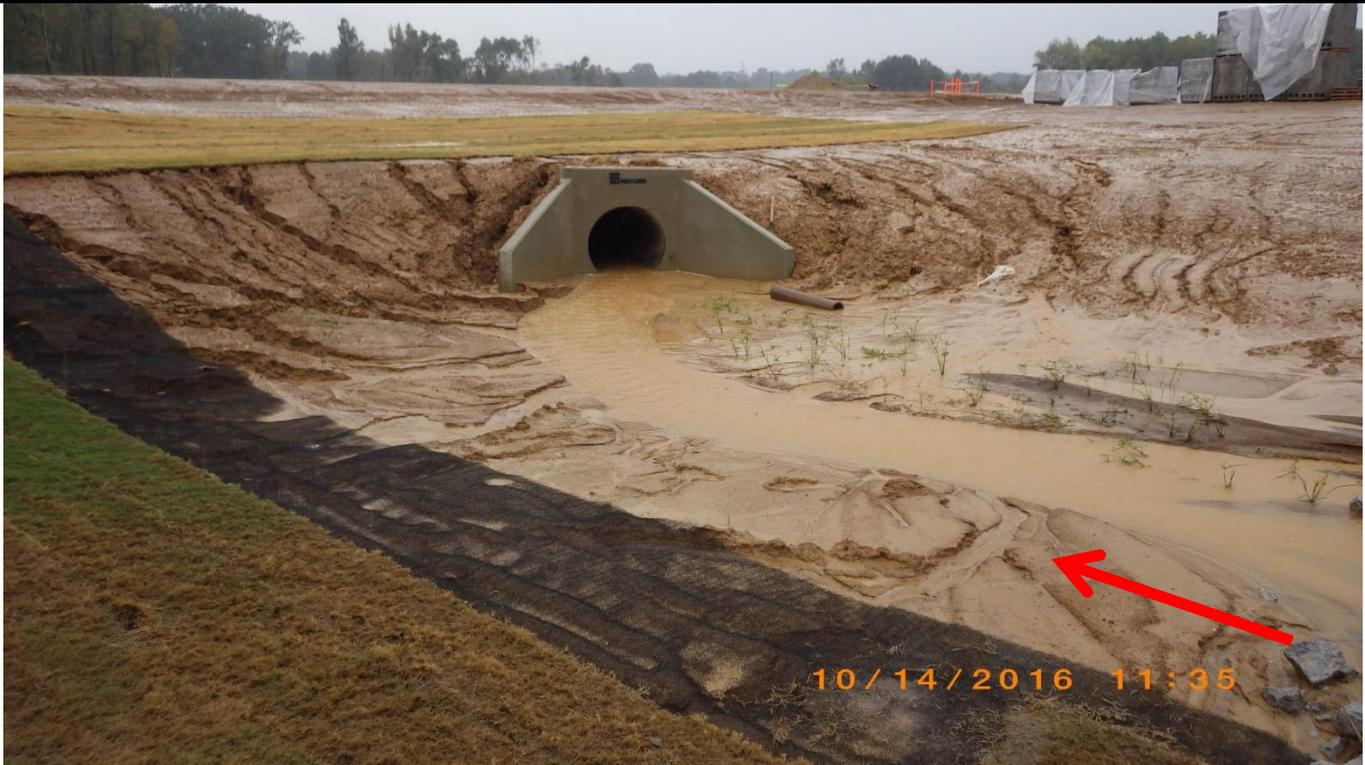
Photo 53. Close-up view of the culvert shown in Photo 52. The area around the culvert inlet had not been stabilized and rills and gullies had started to form around the inlet. EPSC measures have not slowed runoff so that rill and gully formation is prevented as required by the TN Individual Construction Permit TN0081787. The direction of flow is indicated with a red arrow.

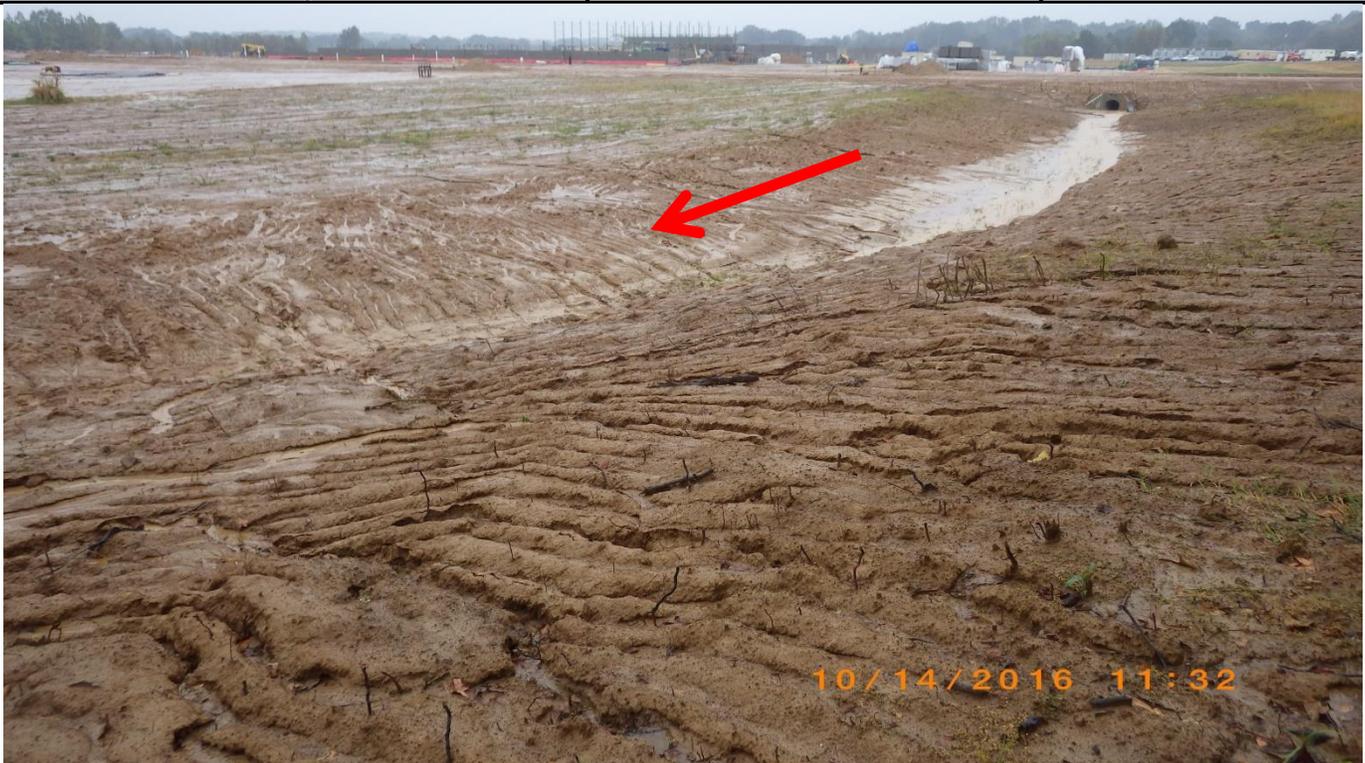
Photo 54. The outlet side of the culvert shown in Photo 53 discharges into an unstable and eroding drainage channel that discharges into the NW sediment basin. EPSC measures have not slowed runoff so that rill and gully formation is prevented as required by the TN Individual Construction Permit TN0081787. The direction of flow is indicated with a red arrow.

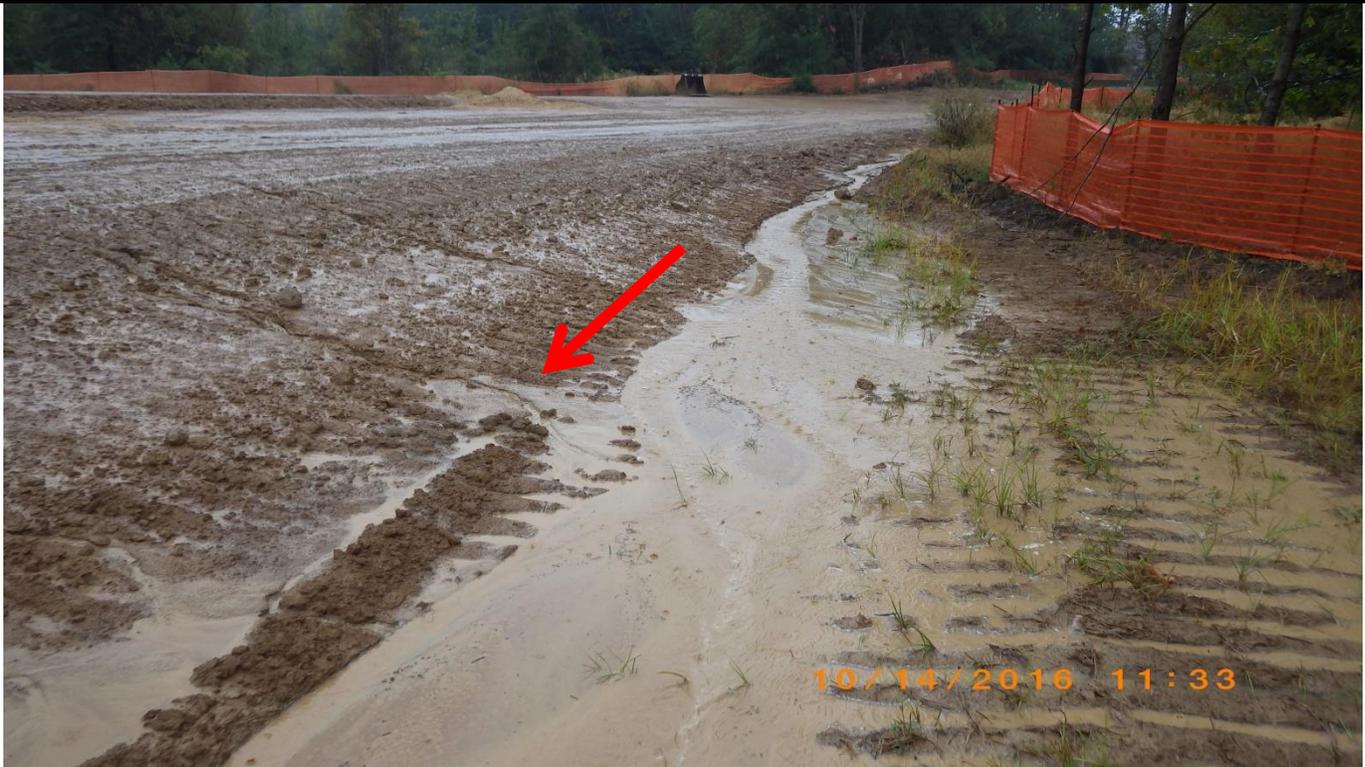
Photo 55. Stormwater entering the construction site on the north side of the entrance road located north of the main construction entrance was creating a rill and transporting sediment laden stormwater to the unstable drainage channel shown in Photo 54. The direction of flow is indicated with a red arrow. EPSC measures have not slowed runoff so that rill and gully formation is prevented as required by the TN Individual Construction Permit TN0081787. The direction of flow is indicated with a red arrow.

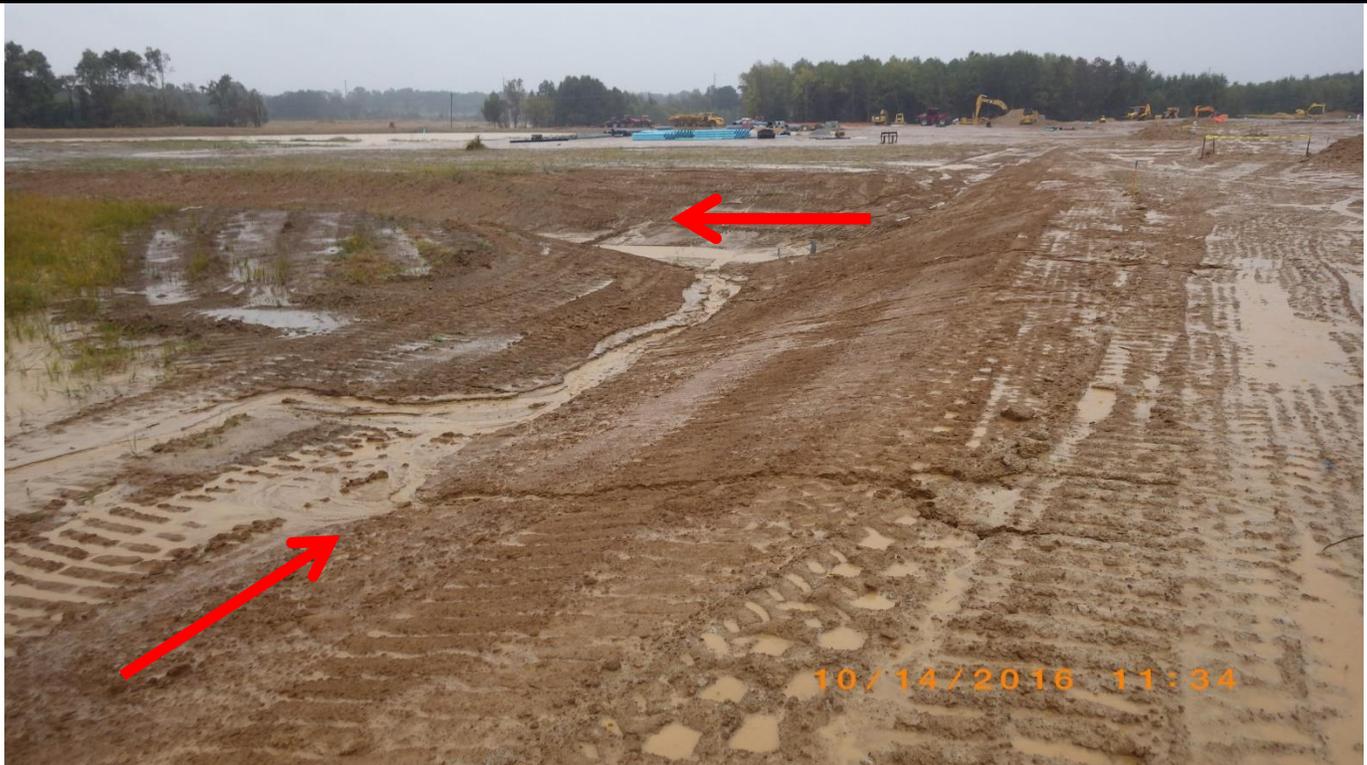
Photo 56. View looking down gradient from the location shown in Photo 55. Stormwater entering the construction site on the north side of the entrance road located north of the main construction entrance was creating a rill and transporting sediment laden stormwater to the unstable drainage channel shown in Photo 54. EPSC measures have not slowed runoff so that rill and gully formation is prevented as required by the TN Individual Construction Permit TN0081787. The direction of flow is indicated with a red arrow. The direction of flow is indicated with a red arrow.

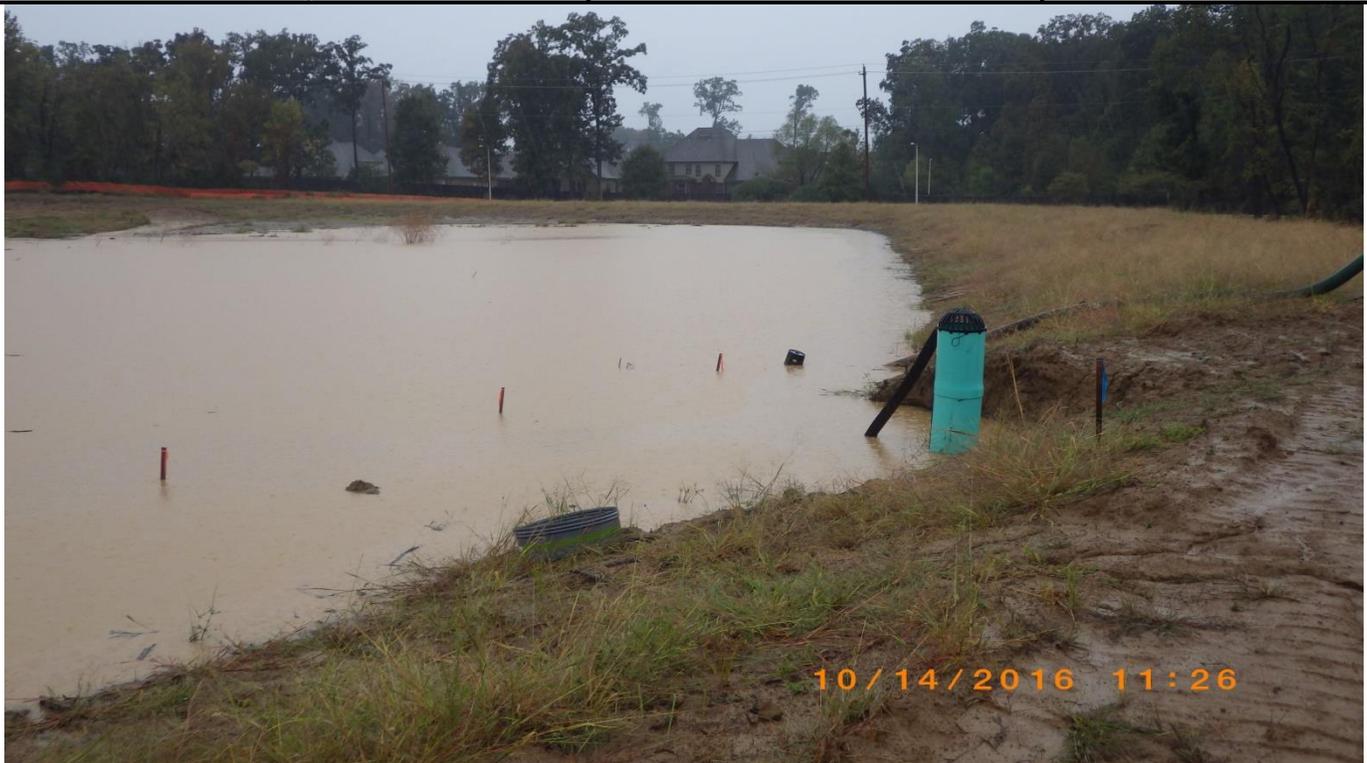
Photo 57. View of the NW sediment basin. It appeared that the sediment basin had a sufficient volume to contain the rain event. The required water depth gauge within the basin had not been installed.
